Manhole Inspection Summary

Manhole # S35II_016MH

Insp Date: **3/12/07 1:17 PM**

Location Address: **1629 SAINT PAUL ST**

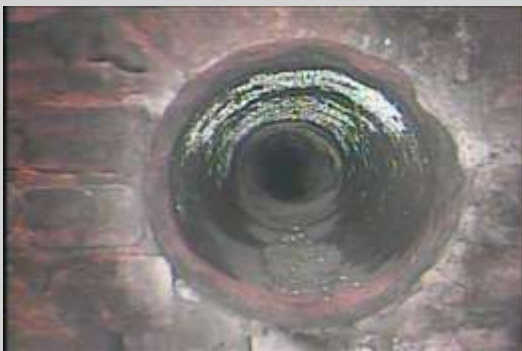
8 in. Circular Gravity Sewer Pipe In @ 3 O'Clock

Pipe Material: **Clay** ☐ Pipe Lined

Invert Depth: **9.21** (ft.) Flow Characteristics: **Slow**

Deposits: ☒ None ☐ Mud ☐ Sludge ☐ Debris ☐ Grease

Infiltration: **None** Pipe Seal Cond: **Unknown**

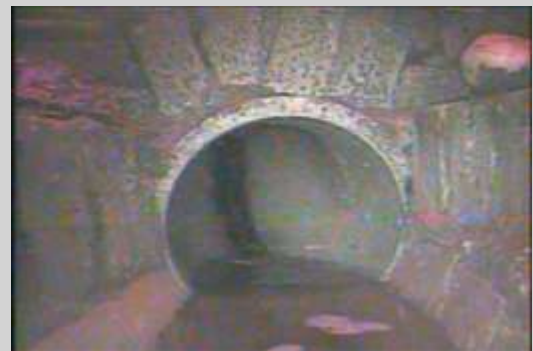
Drop In @ 3 O'Clock

Drop: **Outside** Rod and Bar

Angled: **Yes** Reading: **11.88** (ft.)

Inv Depth: **12.88** (ft.)

Drop Condition: **Open**

Connects To: **Manhole**

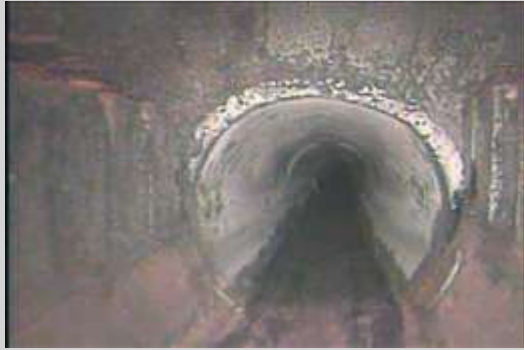
8 in. Circular Gravity Sewer

Pipe Material: **Clay**

Infiltration: **None**
